A new exceptional event in the Rio Cordon basin: new challenges are coming after the October 2018 flood

RIO CORDON BASIN

CHARACTERISTICS OF THE EVENT

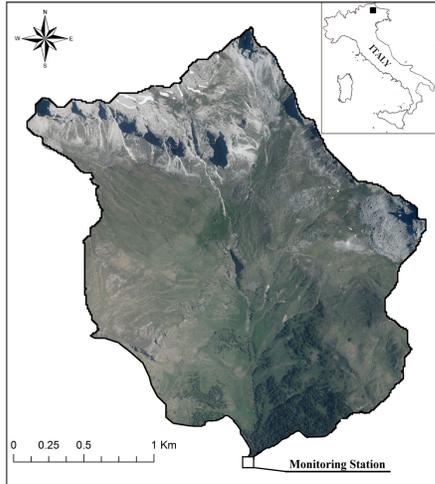
Fig. 1: The Rio Cordon basin

- The Rio Cordon basin (5 km²) exhibits a prevalent **nivo-pluvial runoff regime**.
- Average annual precipitation (1986-2017) = **1150 mm**
- The Rio Cordon stream is a **steep mountain channel** (mean slope = 13%) with step-pool and boulder-cascade morphology.

- **Forests** (*Picea abies* and *Larix decidua*) cover just 7% of the catchment area and are located in the lower part of the basin. Most of the catchment features **Alpine grasslands** (61%) and **shrubs** (18%). The remaining 14% of the basin is **bare land**.

- Since **1986**, the catchment is equipped with a permanent **monitoring station**, which continuously measures the water and sediment fluxes as well the climatic conditions.

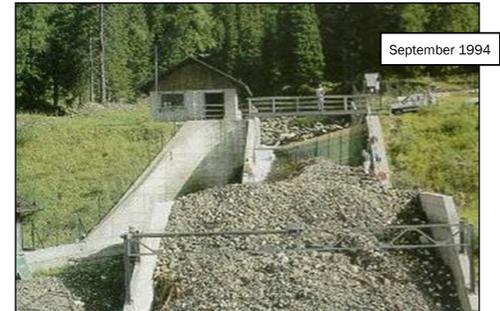
Fig. 2: Bedload material transported by September 1994 event

- **31 flood events** were recorded in the period 1986-2017. The highest magnitude was exhibited by the **September 1994 event**: intense precipitations triggered a flood with a peak of discharge equal to 10.40 m³ s⁻¹ and the transport of ~ 900 m³ of bedload material.

- The event of September 1994 altered the streambed configuration and created new sediment sources throughout the watershed. Consequently, an increase in the transport efficiency and an intensification in sediment fluxes were observed for about a decade after the event. For these reason it was defined as an **“exceptional event”**.

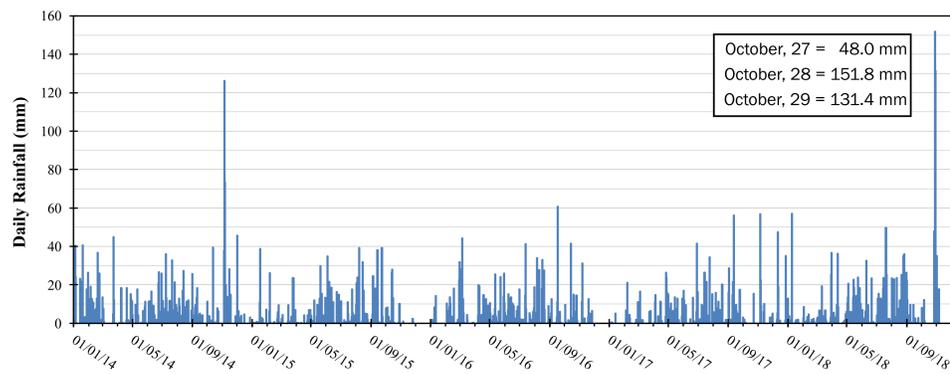
Fig. 3: Daily rainfall recorded in the Rio Cordon basin since 2014 to the present.

Between October, 27 and October, 29 a rainfall amount of **331 mm** were recorded, which corresponds approximately to the **30% of average annual precipitation**. The discharge data gathered are still to be elaborated but the water discharge exhibited by the Fiorentina torrent at the Sottorovei station (managed by ARPA Veneto and located 6 km south-west of the Rio Cordon basin) permit to better comprehend the magnitude of the event. In fact, the Rio Cordon watershed (5 km²) is a sub-catchment of the Fiorentina basin (58 km²).

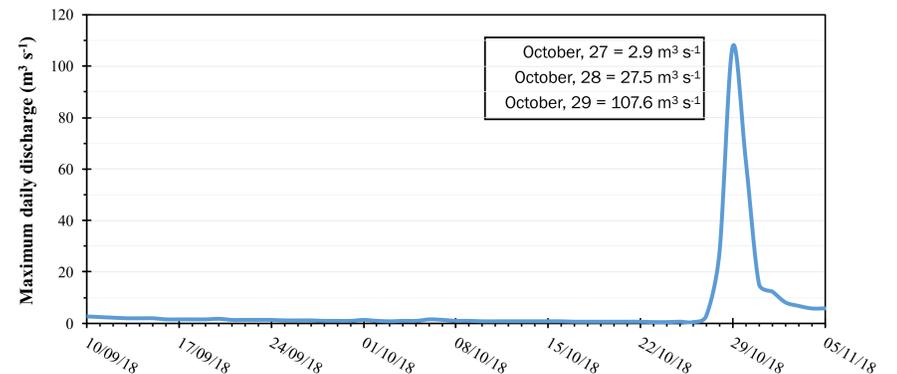
Fig. 4: Maximum daily discharge recorded in the Fiorentina torrent at Sottorovei station (6 km south-west of the Rio Cordon basin, managed by ARPA Veneto).

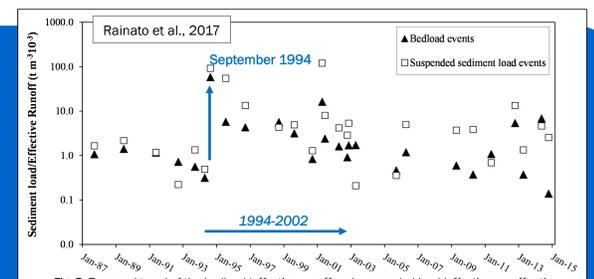
Fig. 5: Temporal trend of the bedload/effective runoff and suspended load/effective runoff ratios.
