# Benefits from sediment reintroduction schemes in rivers

Case studies on the Upper Drac and Buech Rivers

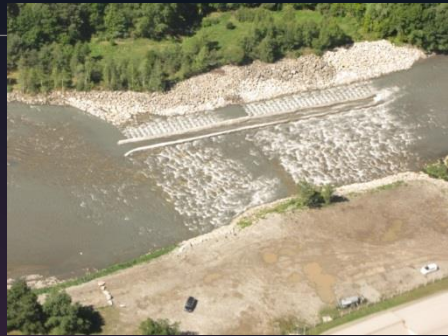
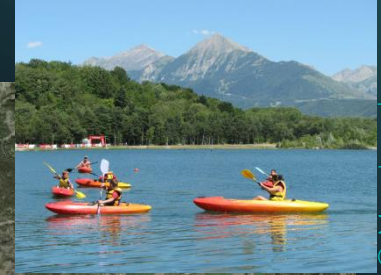
# Study reach and its context

Past gravel mining (1980)

Weir (stabilize long profile) and fish pass

Chabottes floodplain, reference reach

Past gravel mining (2012)

Study reach: 3.6 km

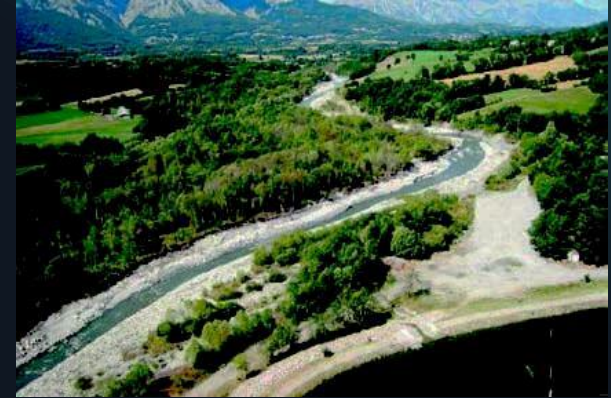
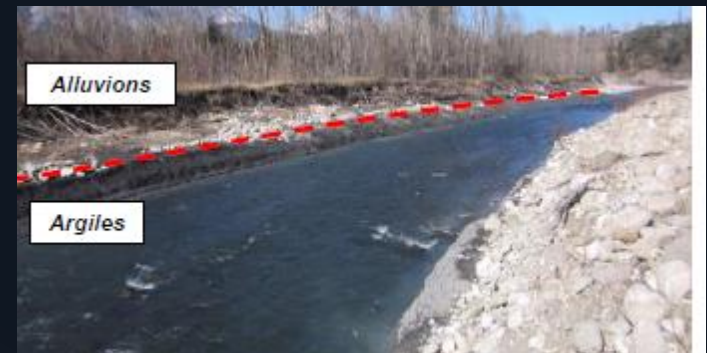
- Dramatic channel incision into lacustrine clay deposits under the effect of gravel mining
- Intense regressive erosion and marked narrowing of the active channel
- A threat for the artificial pond of the Champsaur leisure center
- Lowering of the water table and subsequent alteration of the riparian forest
- Alteration of aquatic habitats related to the loss of gravel substrate and to the expanding clay outcrops

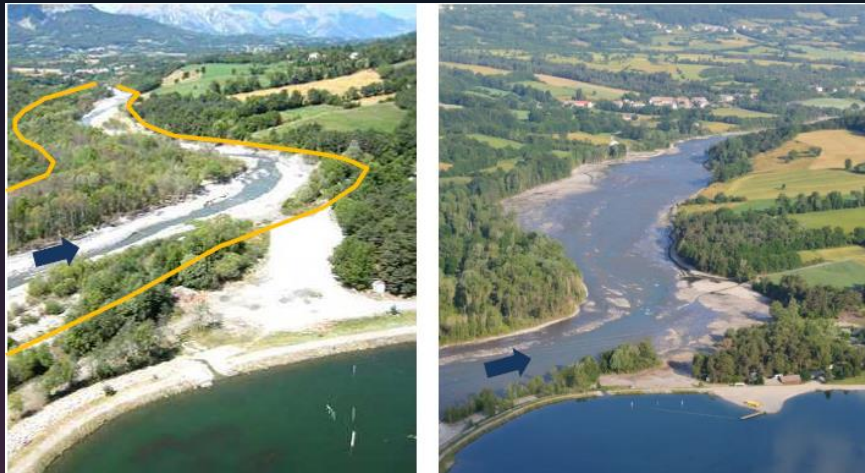
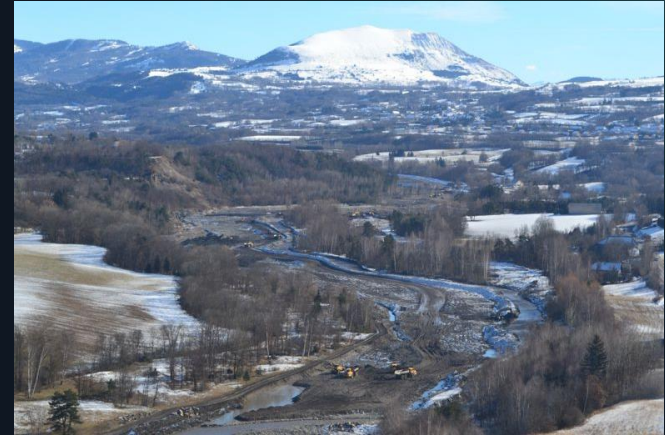
Between 11/2013 and 04/2014

355,000 m<sup>3</sup> of sediment from alluvial terraces reintroduced

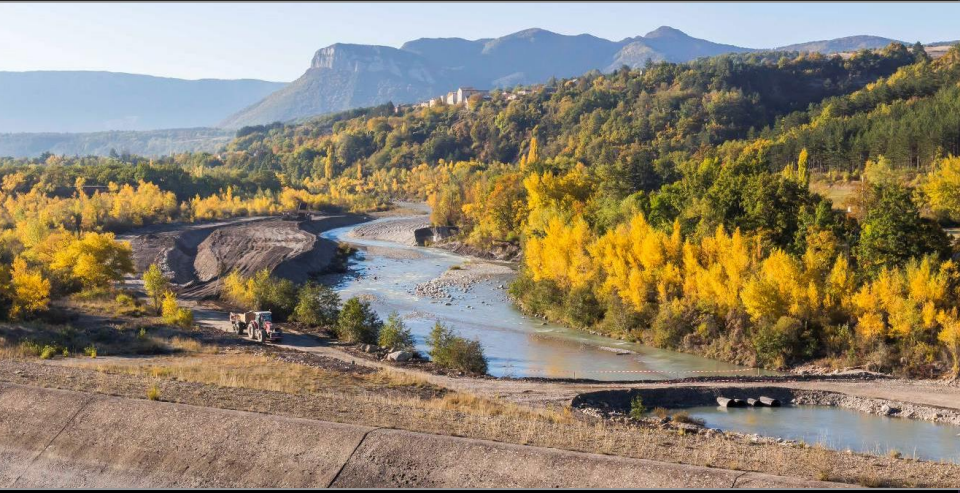
Rectangular cross-section to form a wide active channel like it was before degradation with a general rise of the bed-level to stop regressive erosion

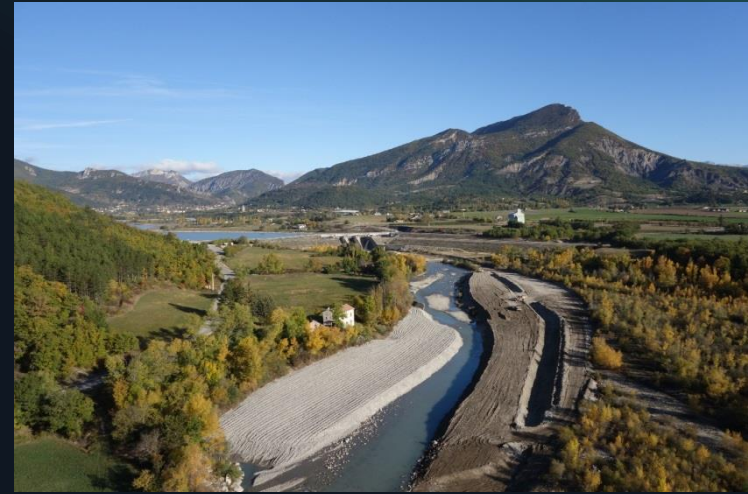
Schematic cross section of the replenishment operation

Dredging the alluvial fan of the Saint Sauveur reservoir

Sediment replenishment downstream of the dam

44,000 m<sup>3</sup>

Central bar

Right bar

Left bar

shaping of a secondary channel

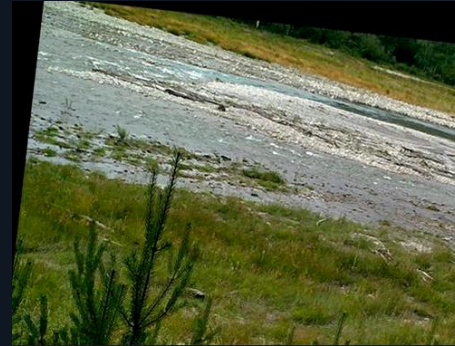
High-frequency qualitative survey of channel changes using time-lapse cameras

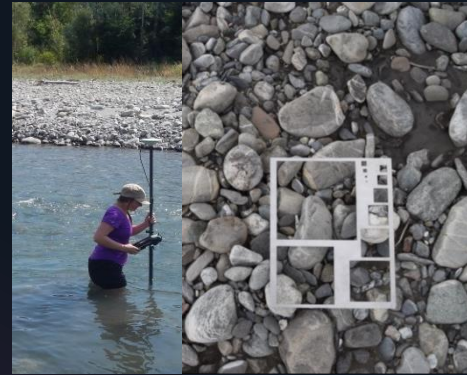
Ancillary field surveys for specific data analysis

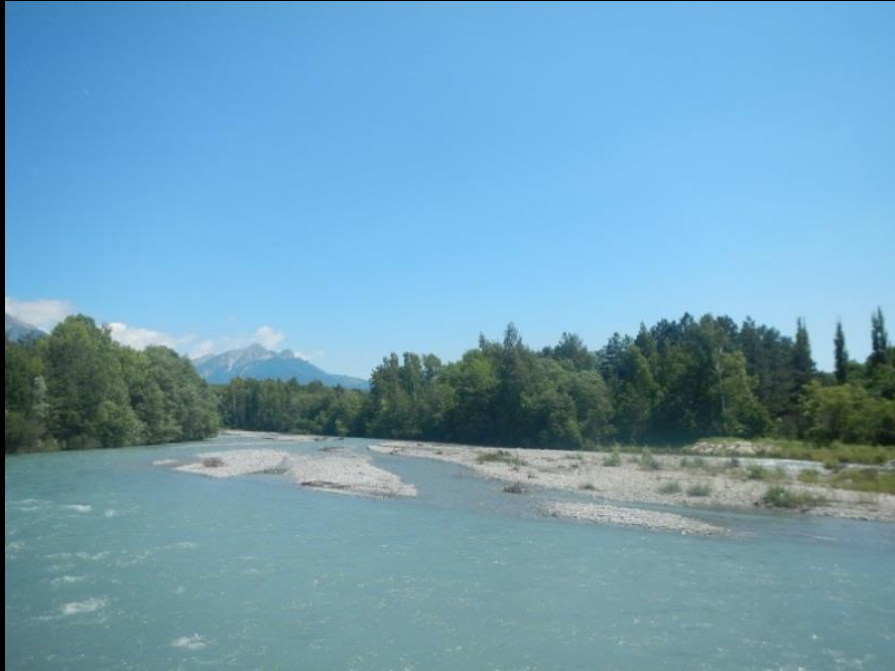
Effects observed after a Q10 flood:  
50% of injected volume remobilized

- Aggradation downstream of the recharge site
- RFID tags have moved up to 2km downstream of the dam

Global aggradation and scour limitation but no braided pattern observed yet

A transfer of gravels from upstream of the dam

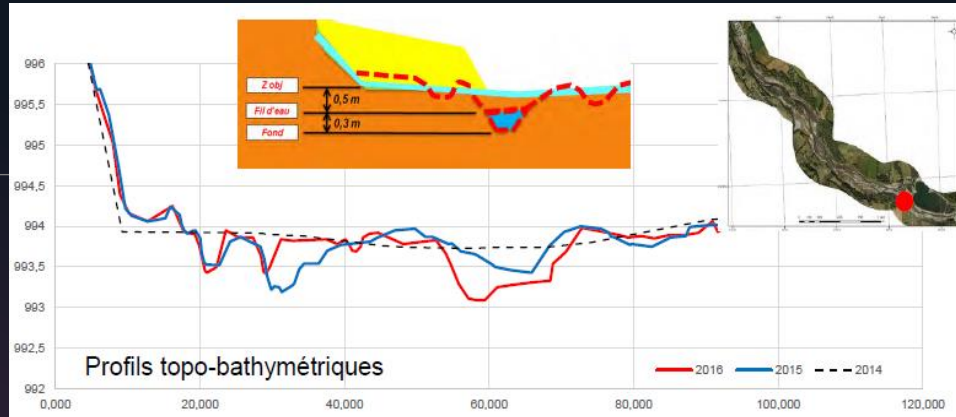
Formation of low-flow channels on the upstream part of the restored reach

On the bed elevation  
Two sectors showed preferential adjustment on the 2014 and 2015 long profiles (Brousse et al. 2017)

A promising trend towards spontaneous braiding recovery

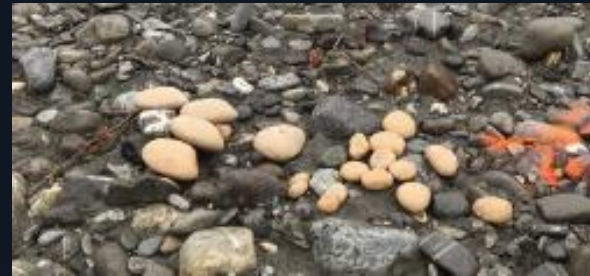
On the distances of bedload transport  
75 RFID Tags deployed on the reference reach (upstream of the restored reach) which covered a maximal distance of 2.9km (after 11 months of monitoring)

A rapid transfer of gravels from the first upper sediment source (the braided Chabottes plain)

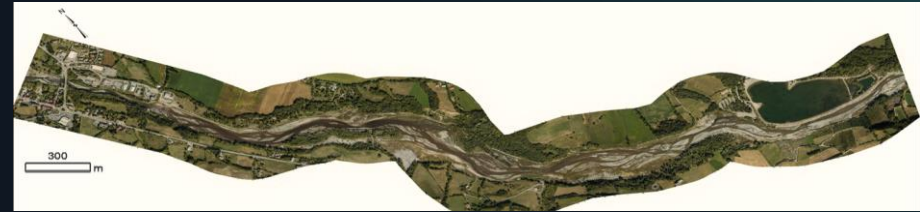
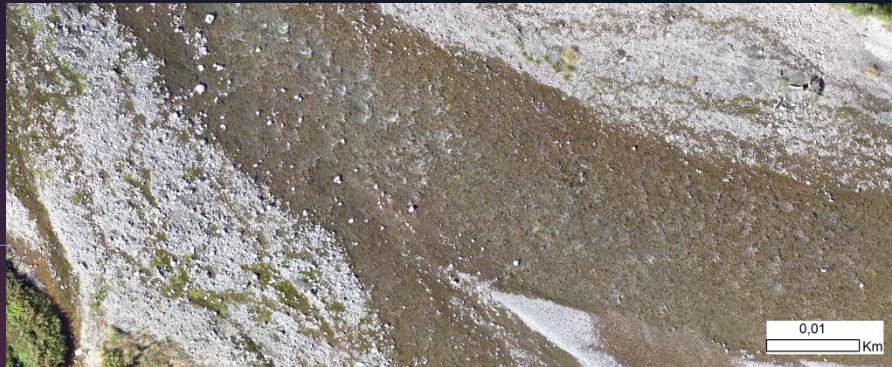
DEM and ortho xy resolution is very high (1-5cm) and errors very low

Point clouds are extended under water (compared to limited LiDAR technics) but have to be corrected

Surficial grain size distribution on gravel bars and under water: parameters (based on manual measurements of the visual gravel sizes on the orthophotos) are correlated with a roughness index of the point cloud → Spatially continuous map of substrate size
